TECHNICAL INSPECTION REPORT

6 OPERATION CROSSROADS.
U.S.S. CRITTENDEN (APA 77)

TEST ABLE.

VOLUME 2 [U].

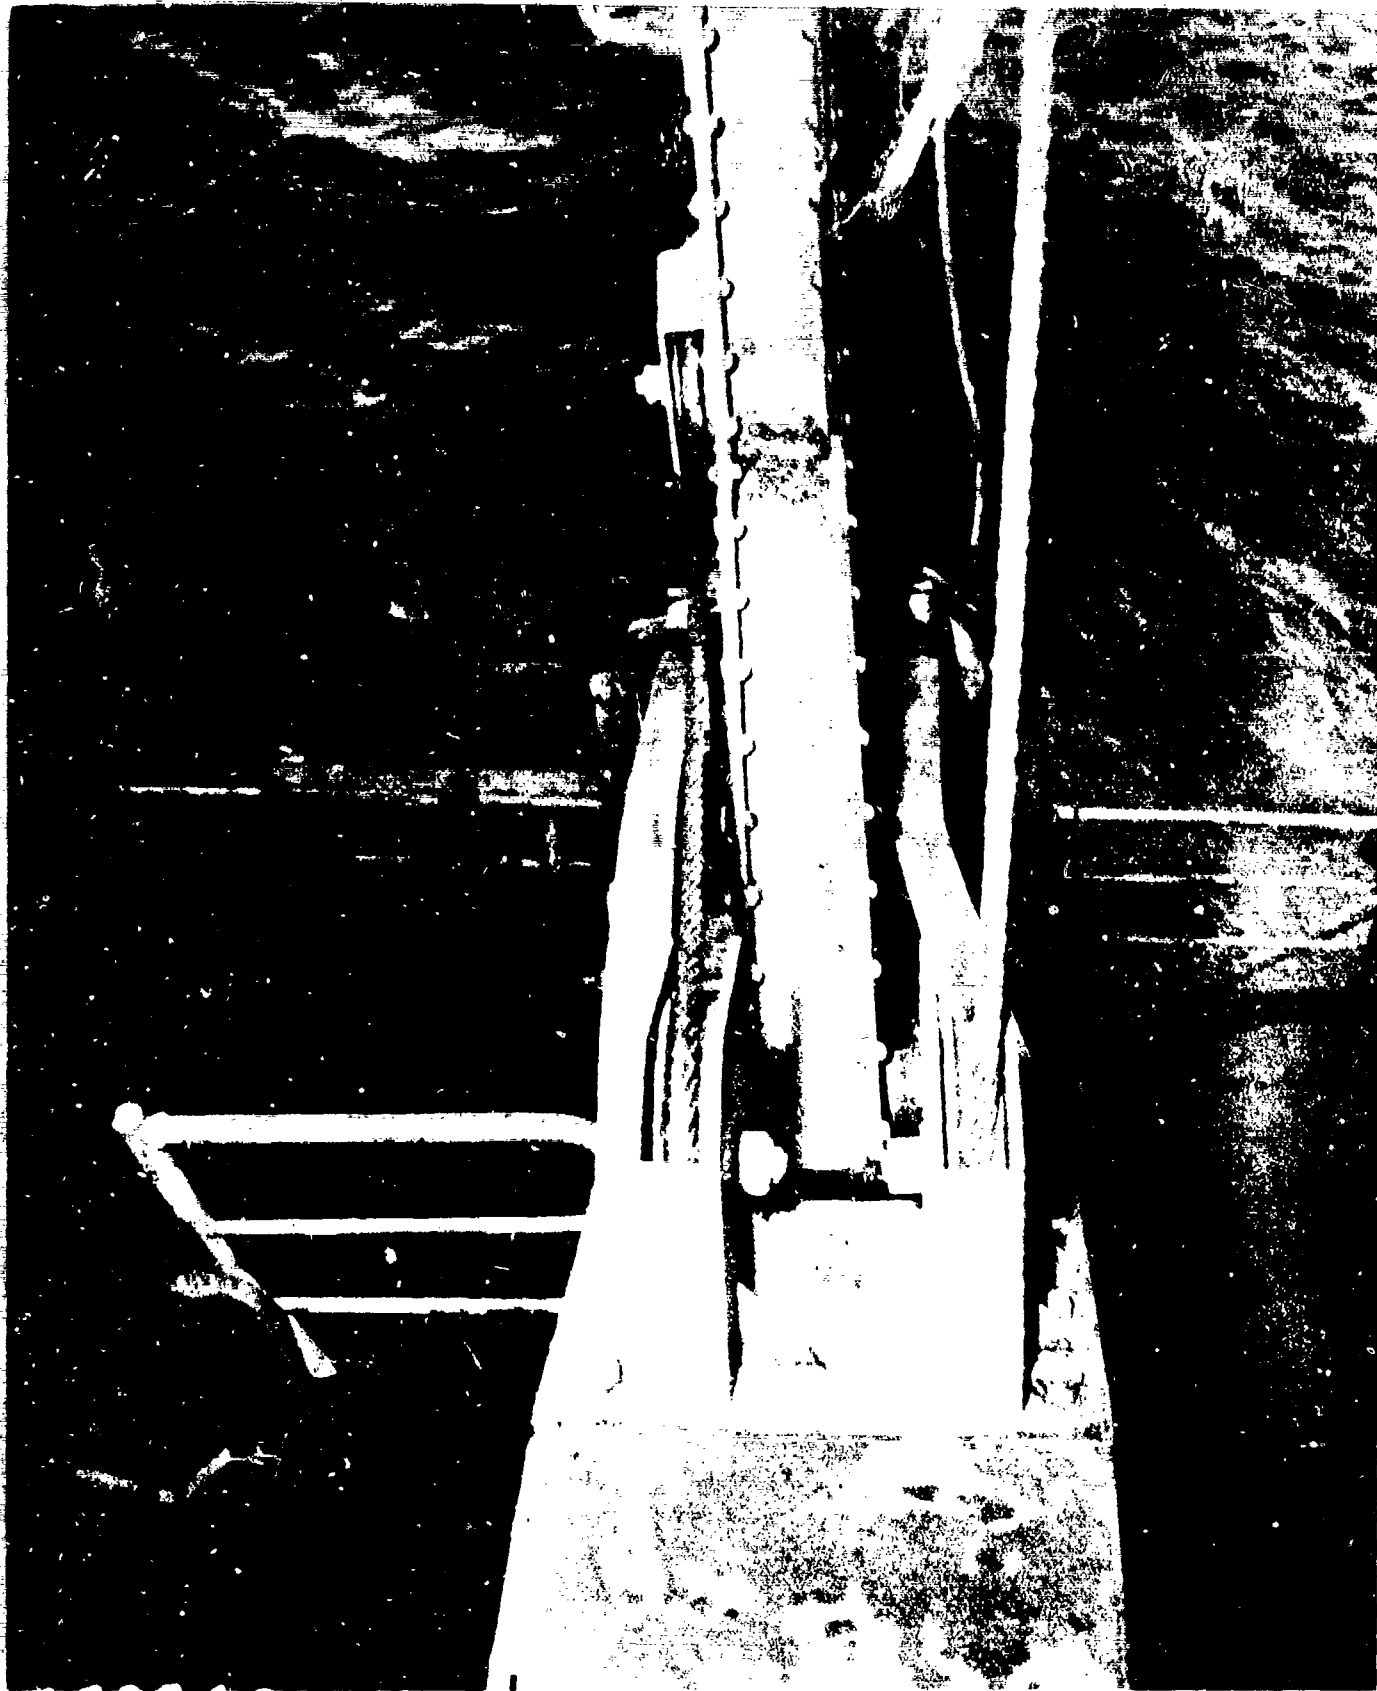
AA-CR-62-1882-7. Looking to port showing damage to after track of number 4 davit.

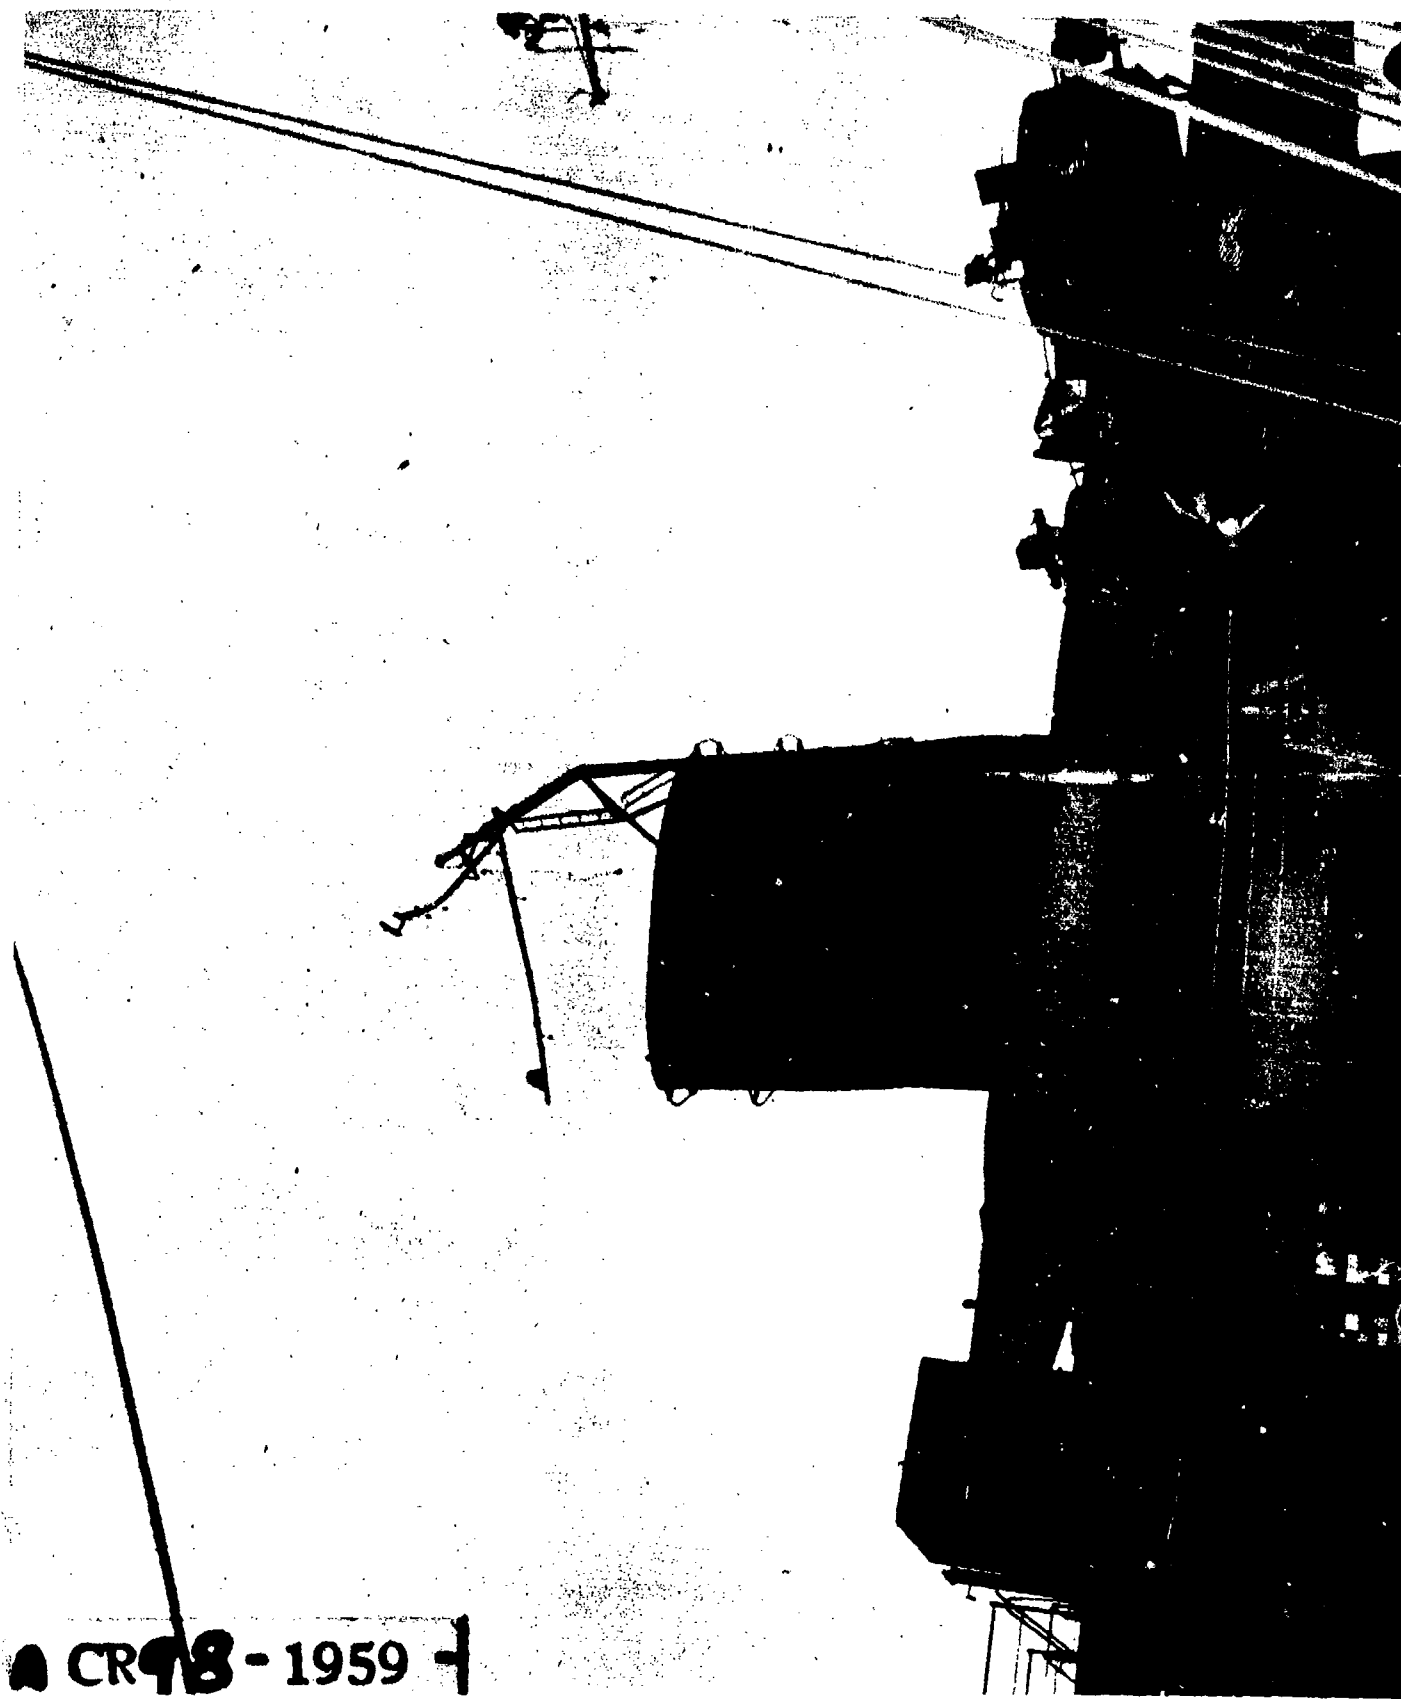
AA-CR-98-1959-9

AA-CR-98-1959-9. Starboard side of superstructure showing undamaged forward boat davit and bent signal yardarms. Note mounting of starboard bullhorn at right margin. Port bullhorn carried away.

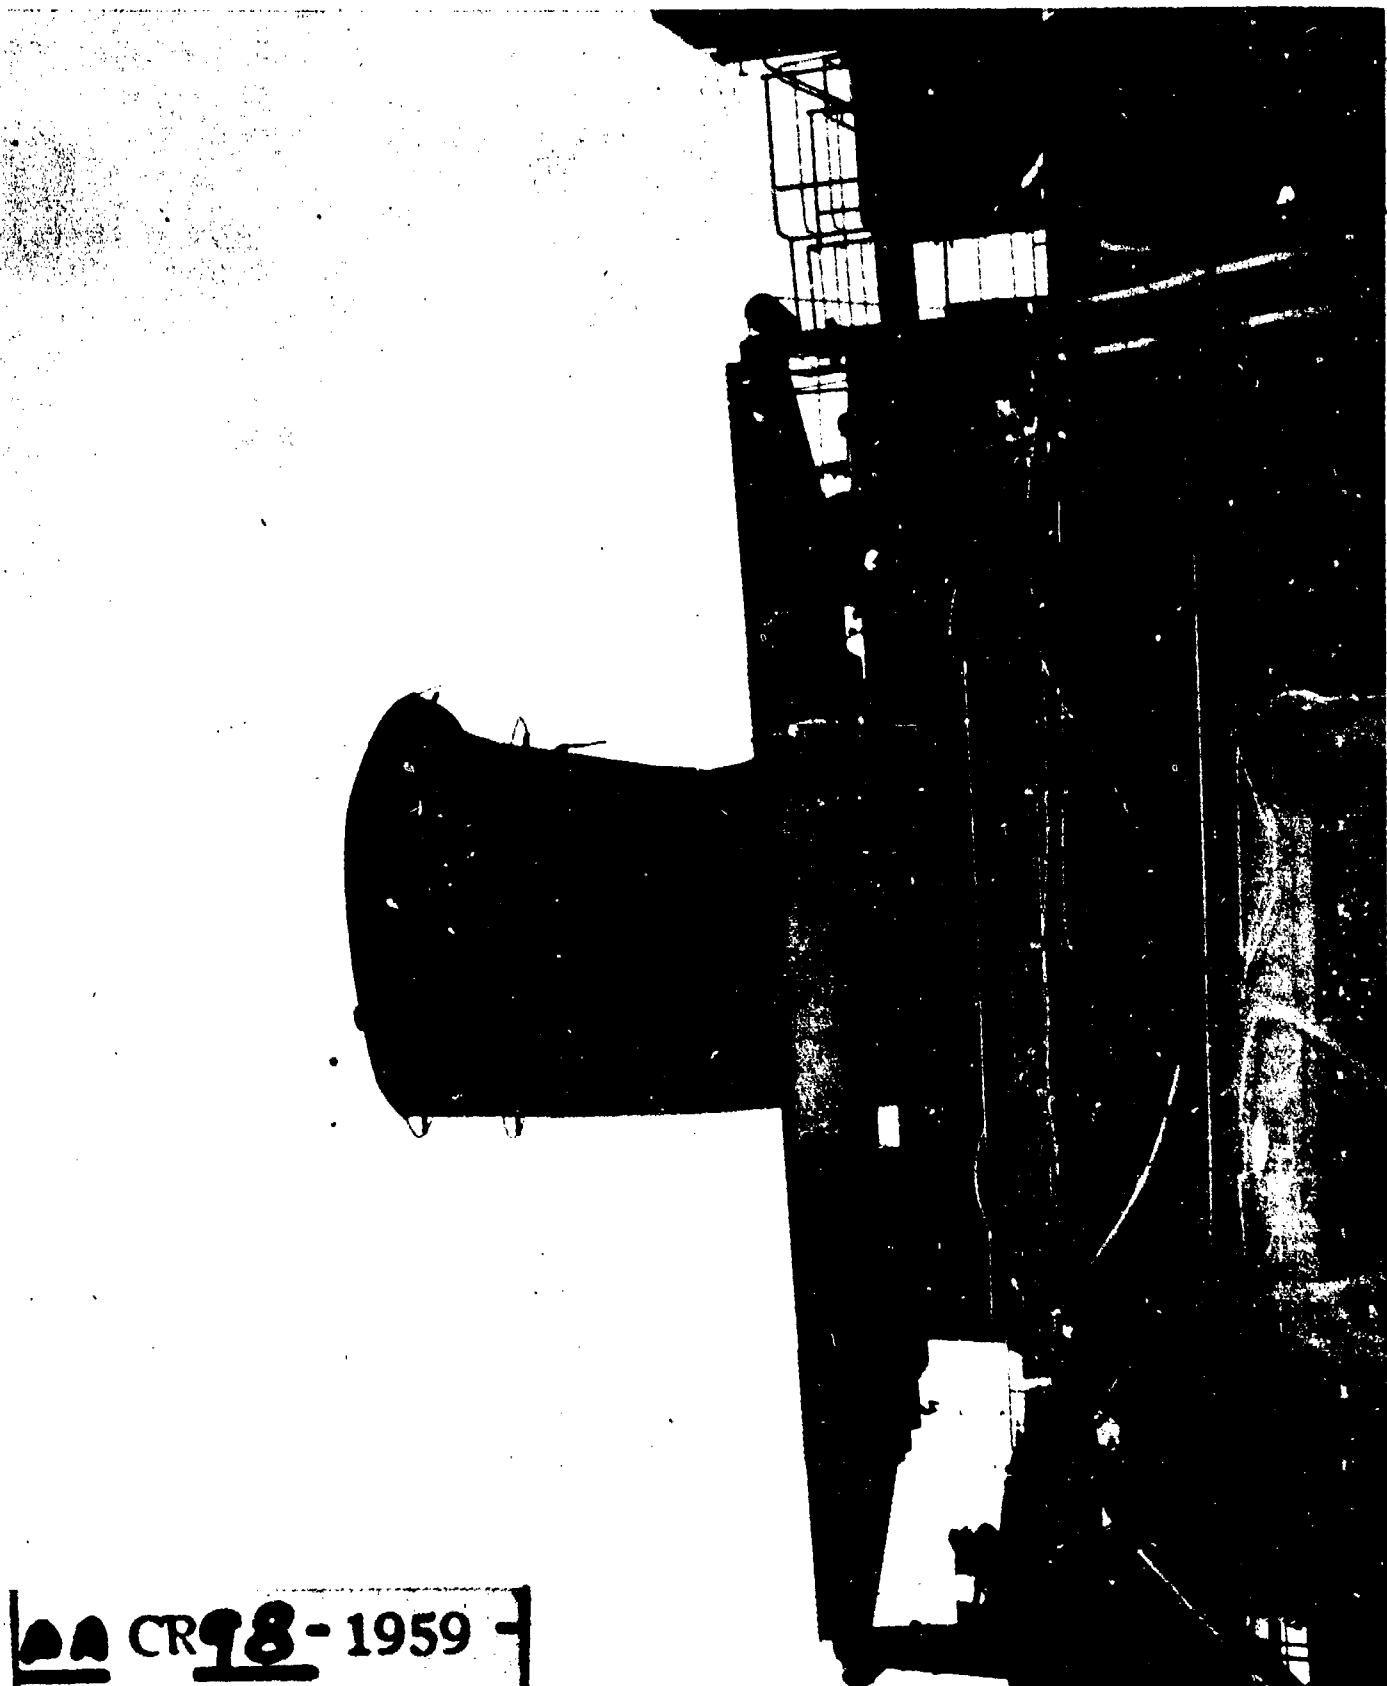
AA CR 98-1959 -

AA-CR-98-1959-10. Starboard side of superstructure showing after
Wellin davits and after stack.

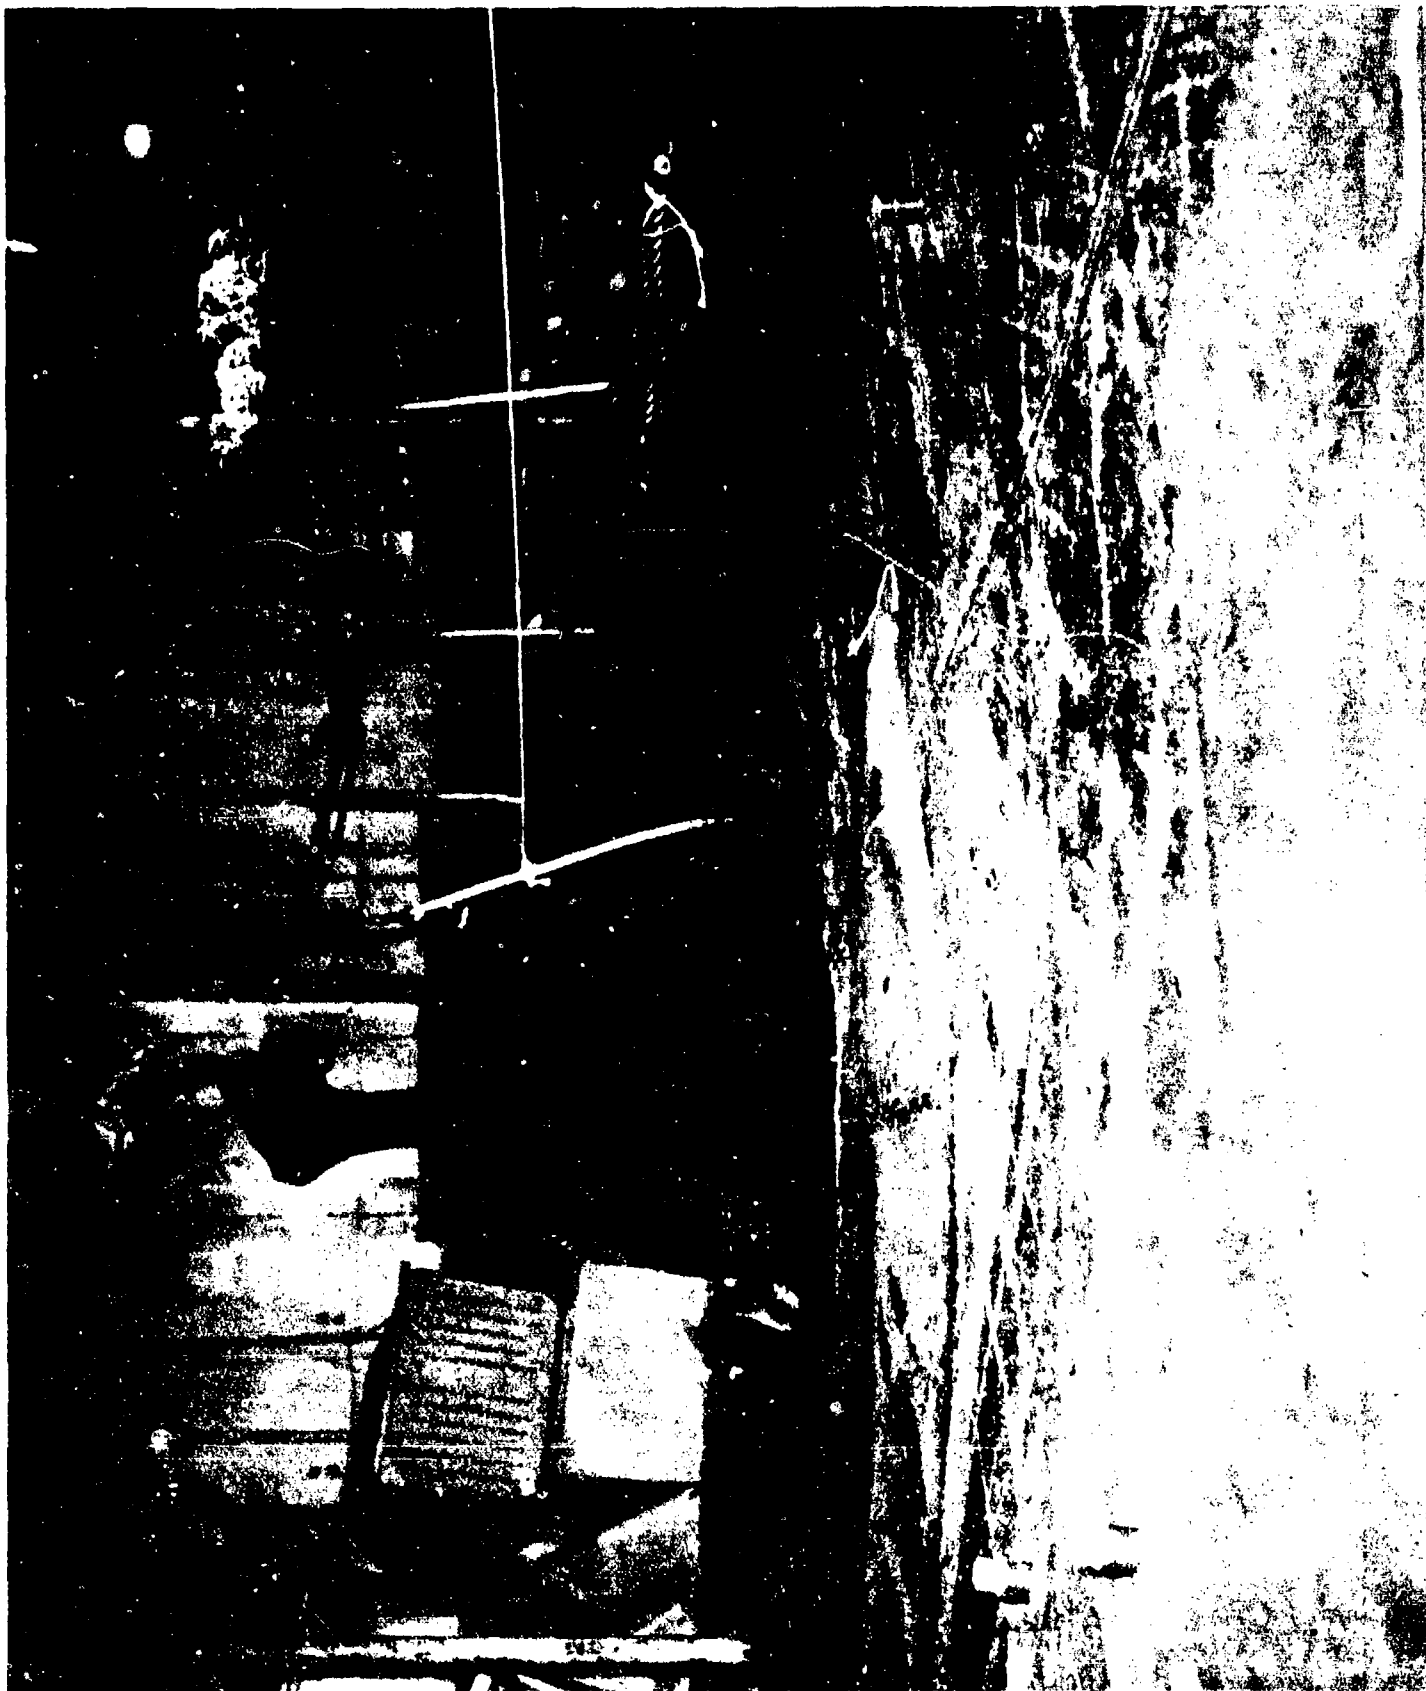
AA-CR-59-2086-4. Looking aft and to port on main deck in forward cargo hatch area showing deck dishing to starboard of hatch.

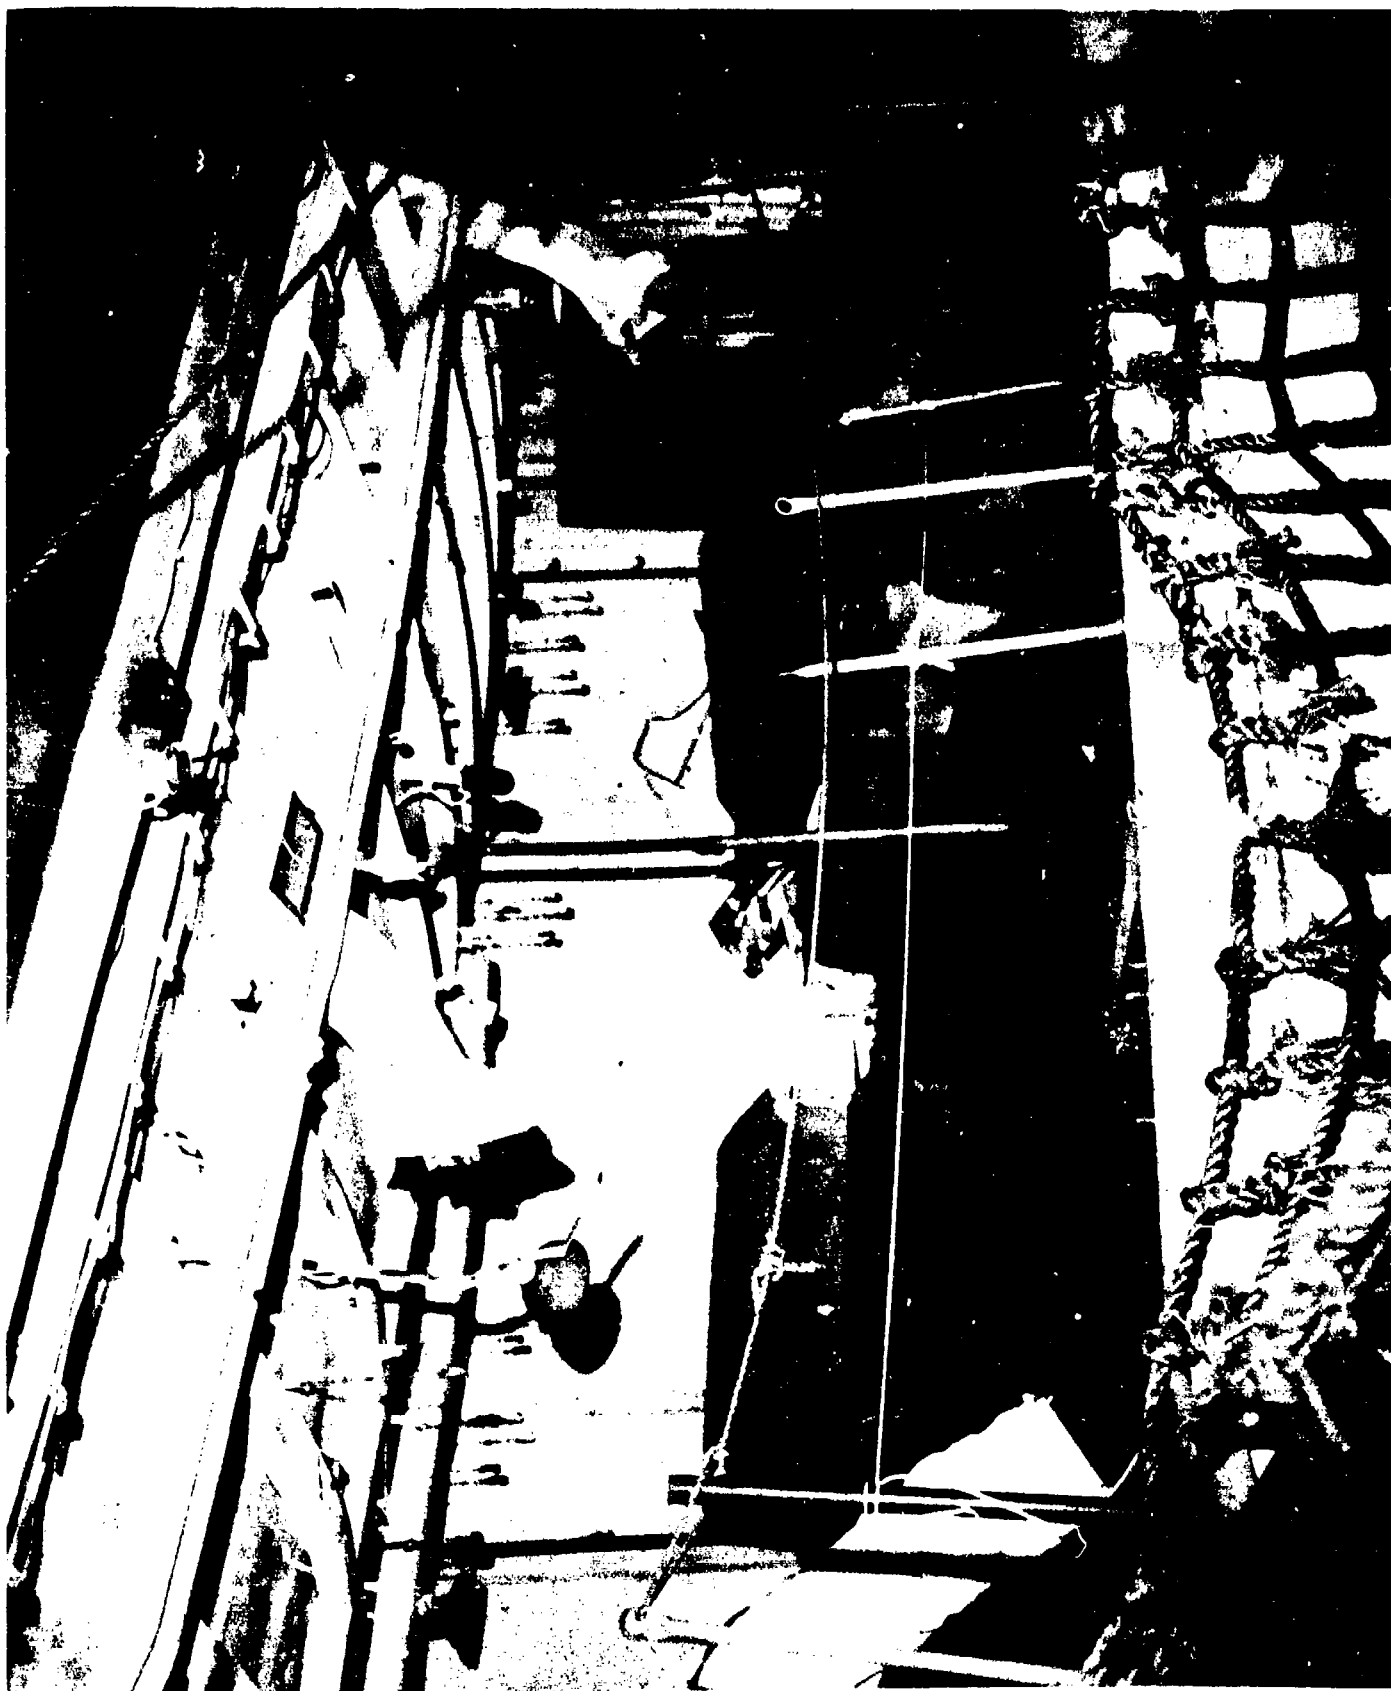
AA-CR-59-2086-5. Looking aft and to starboard on main deck in forward cargo hatch area showing damage to ventilation ducts.

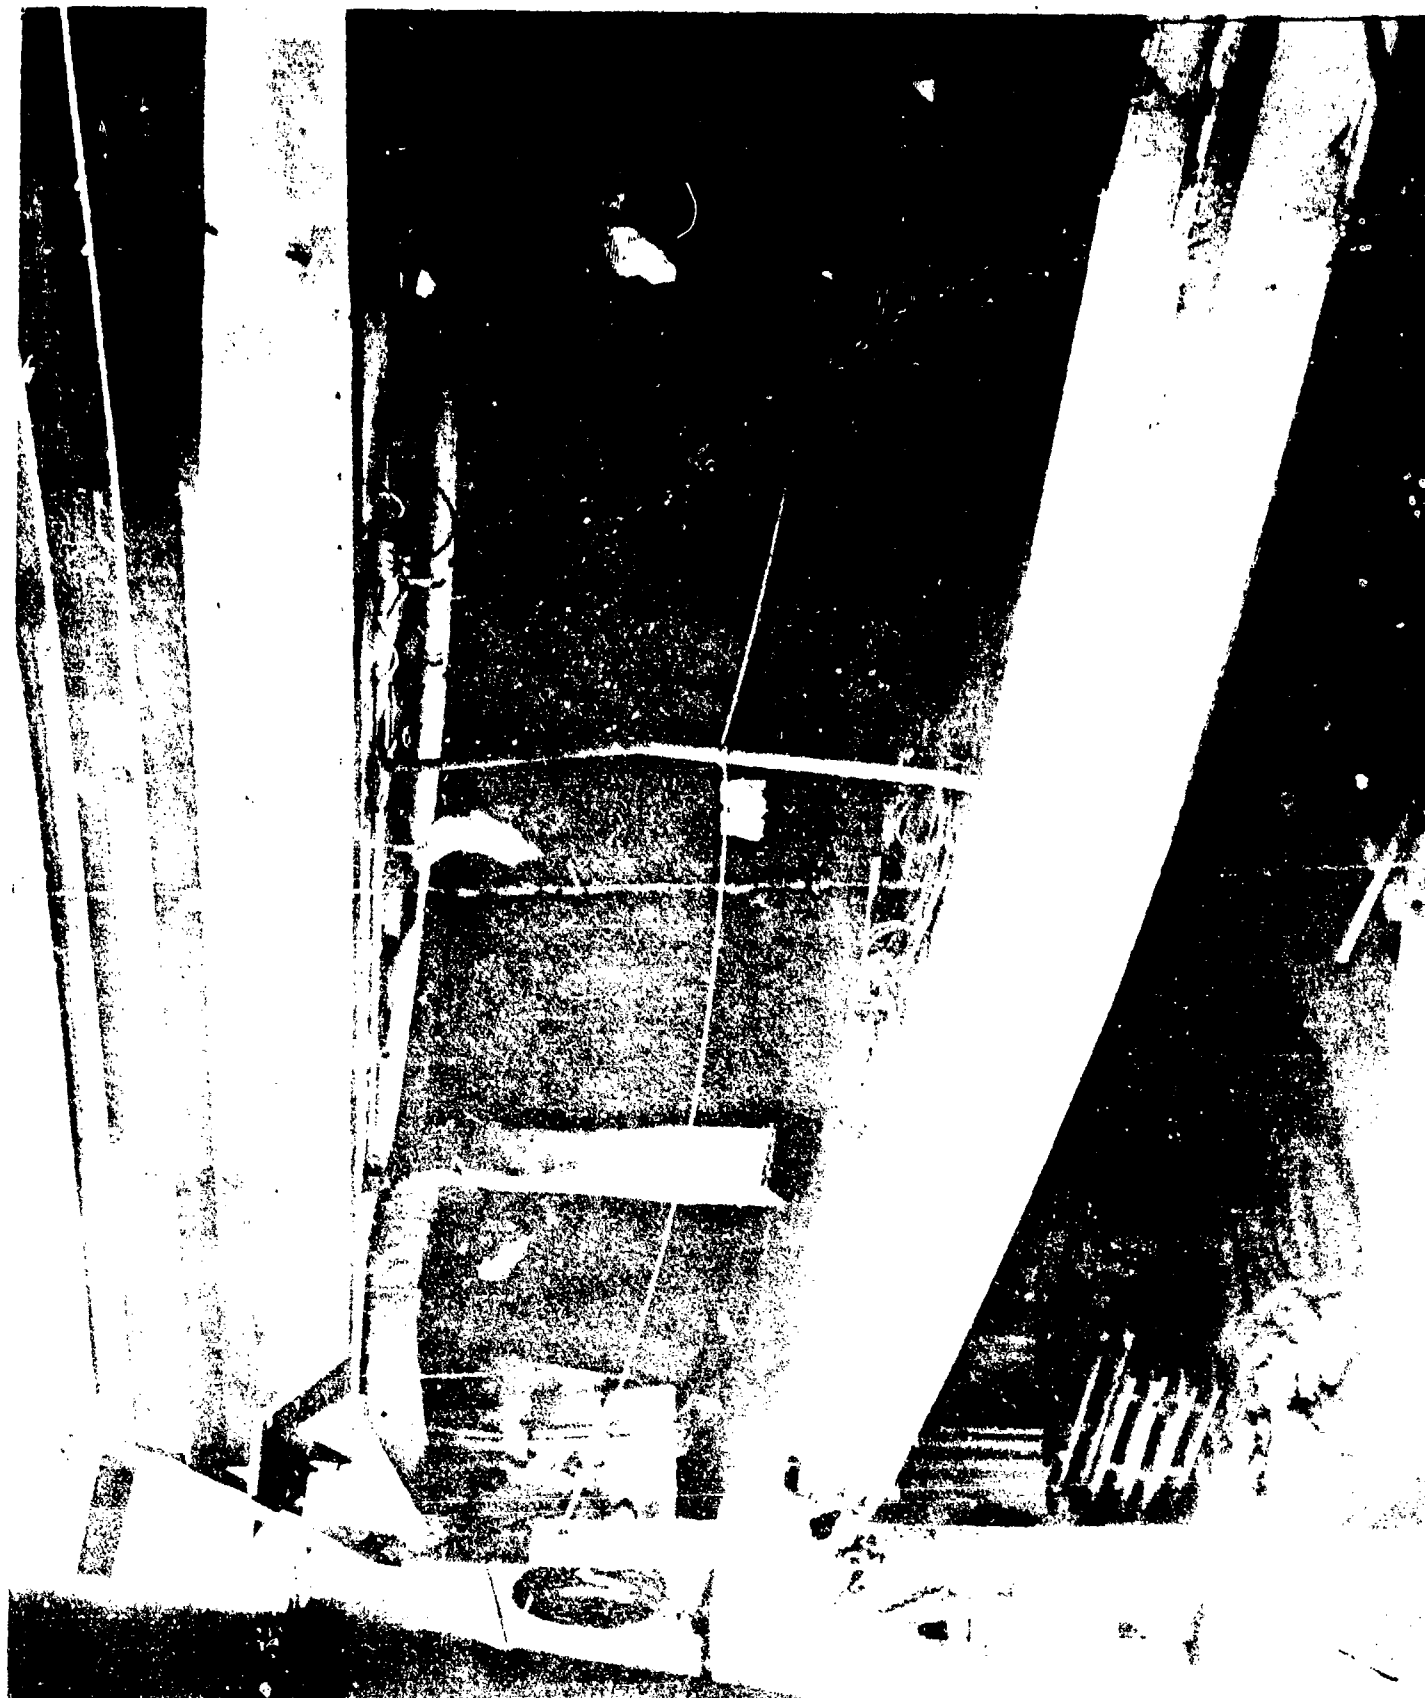
AA-CR-88-2101-1. Looking forward and to starboard on main deck in forward cargo hatch area showing bent hatch coaming.

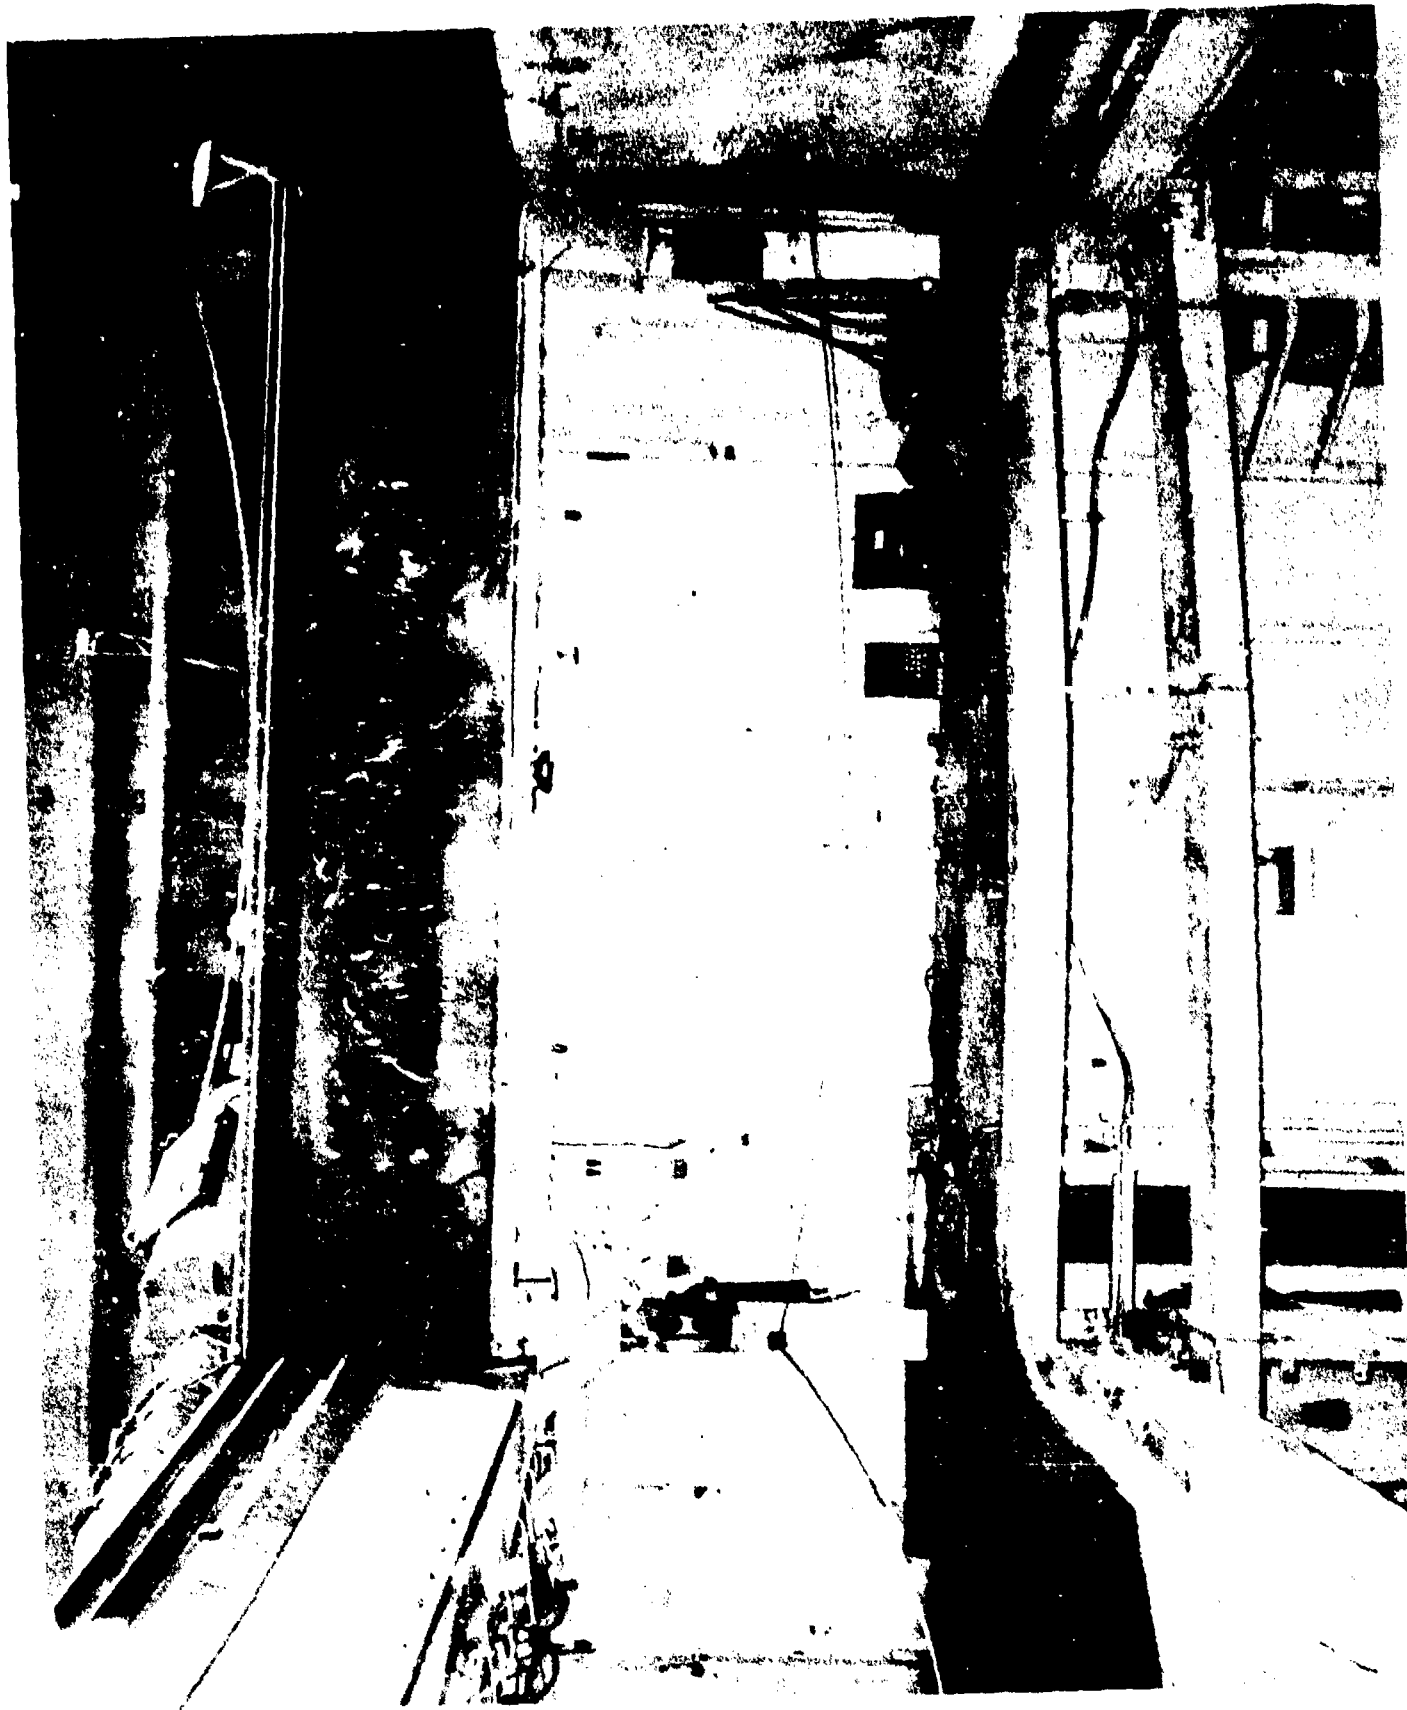
AA-CR-88-2101-5. Looking aft on main deck level in forward cargo hatch area.

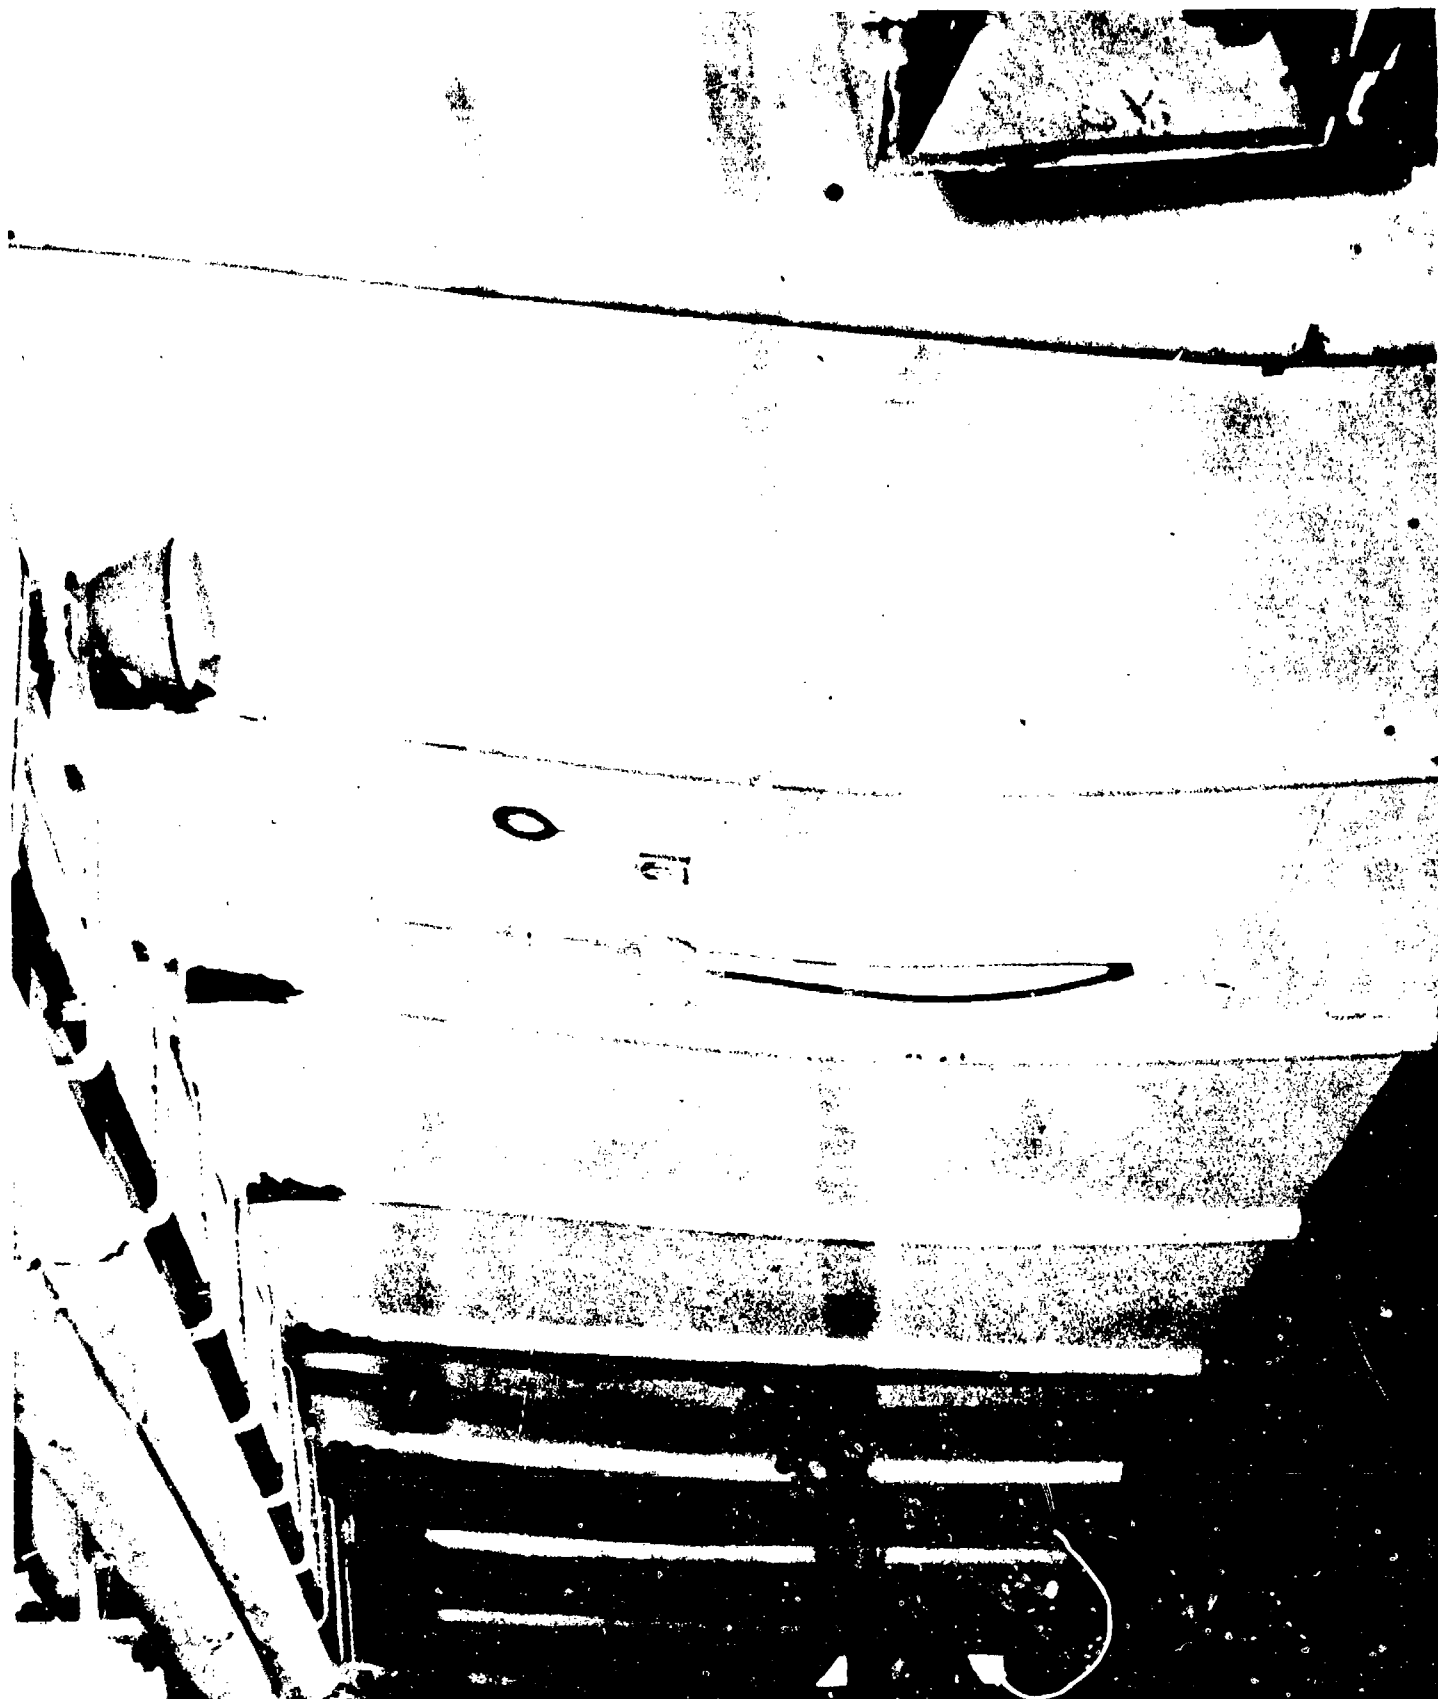
AA-CR-88-2101-6. Deflected light structural bulkhead, main deck, along port edge of forward cargo hatch.

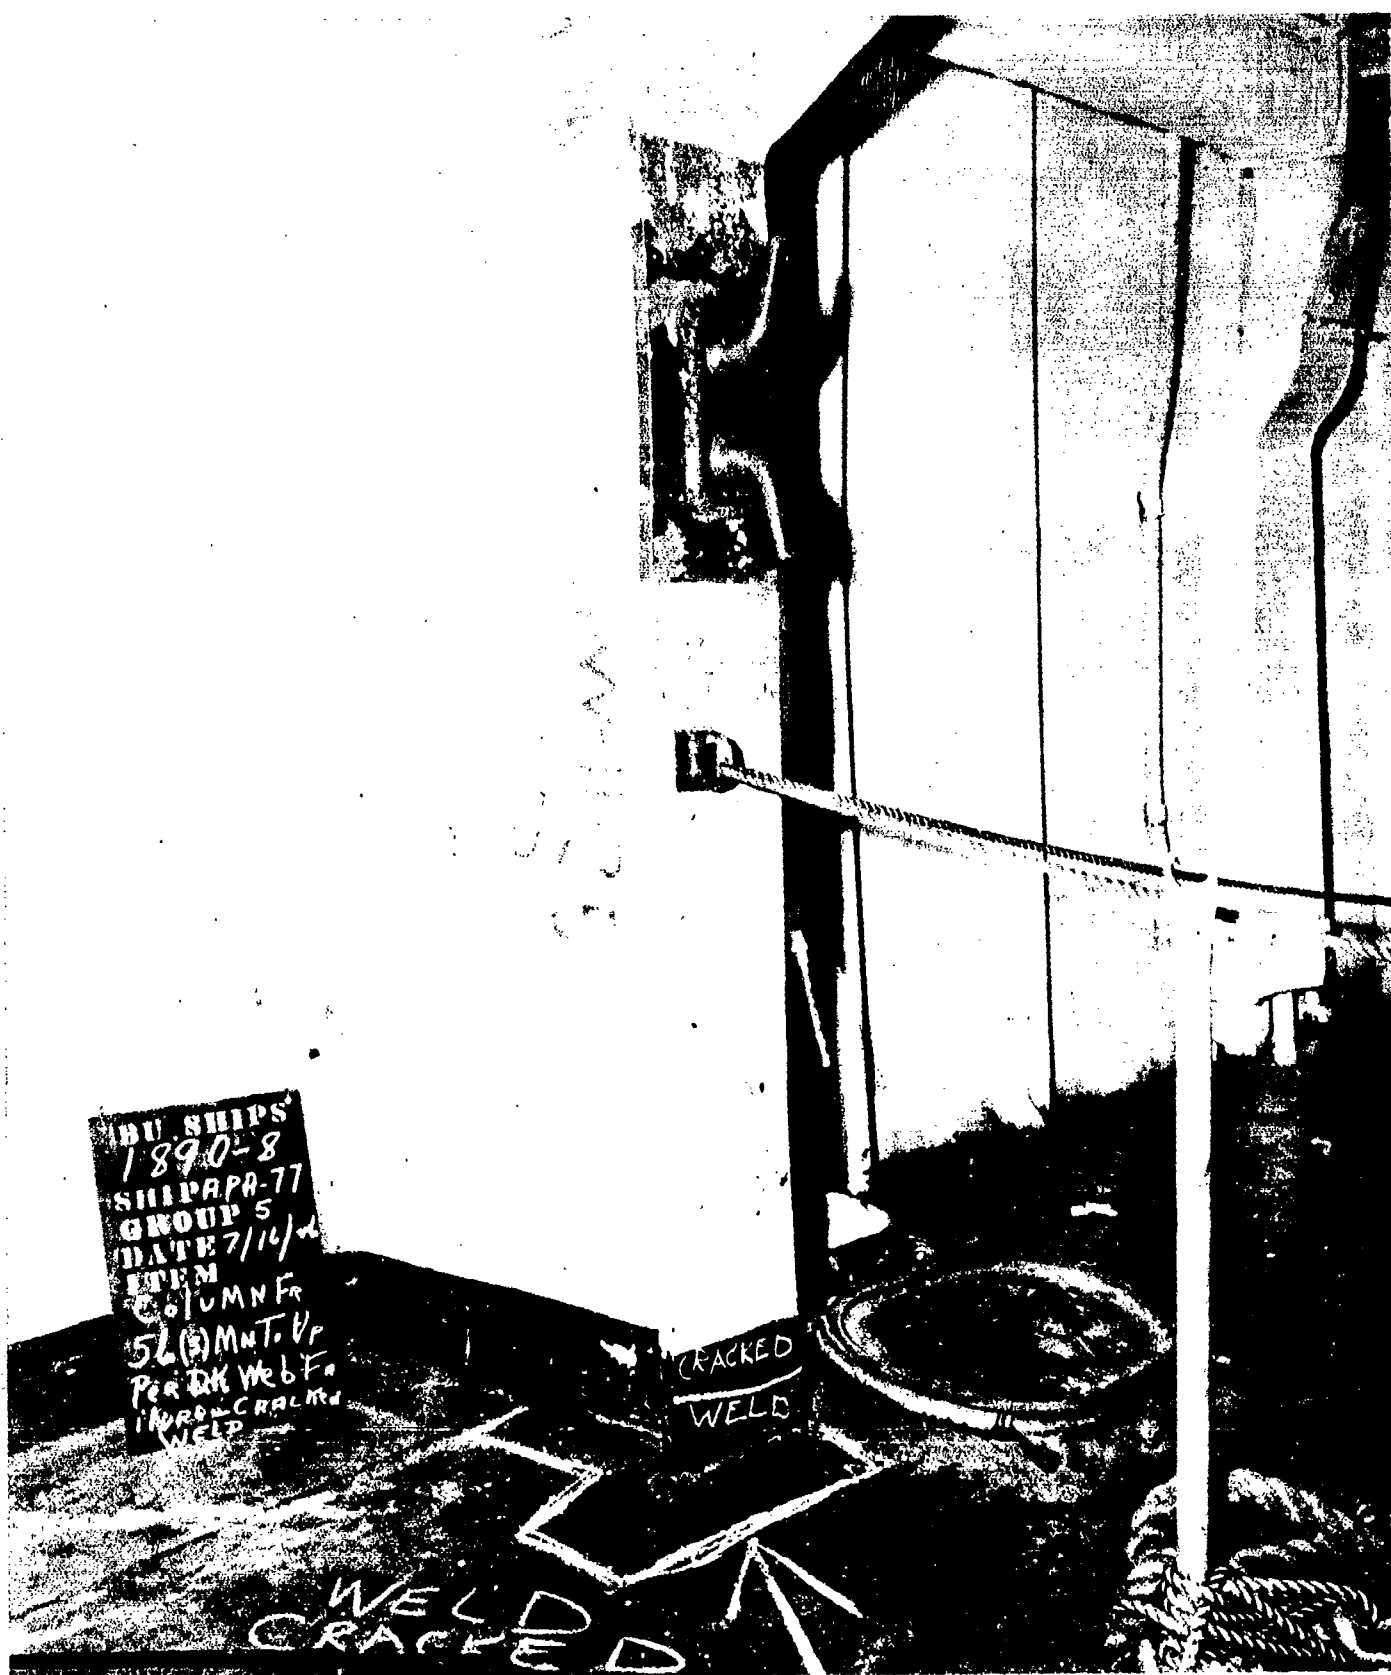
AA-CR-100-1890-8. Looking aft and to starboard on main deck in forward cargo hatch area showing damage to column at bulkhead 56 in way of starboard edge of hatch, and cracked weld at connection to deck. Refer to 2086-2.

AA-CR-59-2086-2. Cracked weld between main deck and column supporting upper deck hatch coaming, frame 56 starboard.
